2023 Juvenile Steelhead Densities in the Corralitos Creek and Casserly Creek Watersheds

December 4, 2023

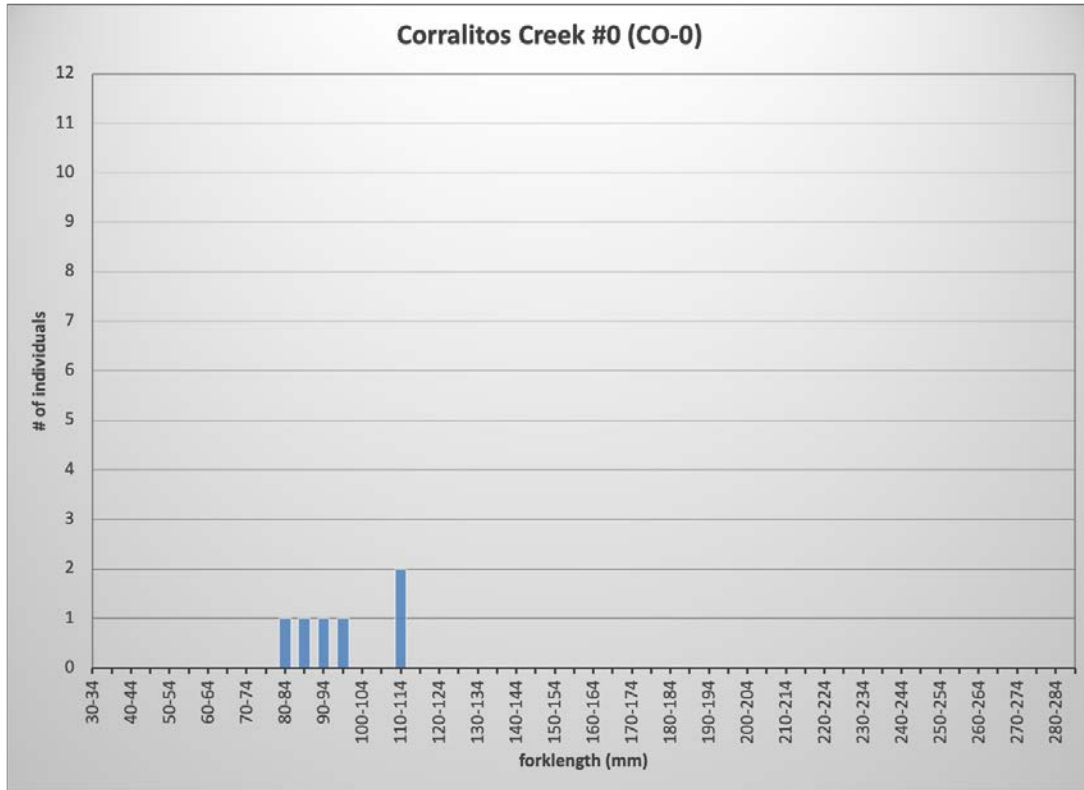
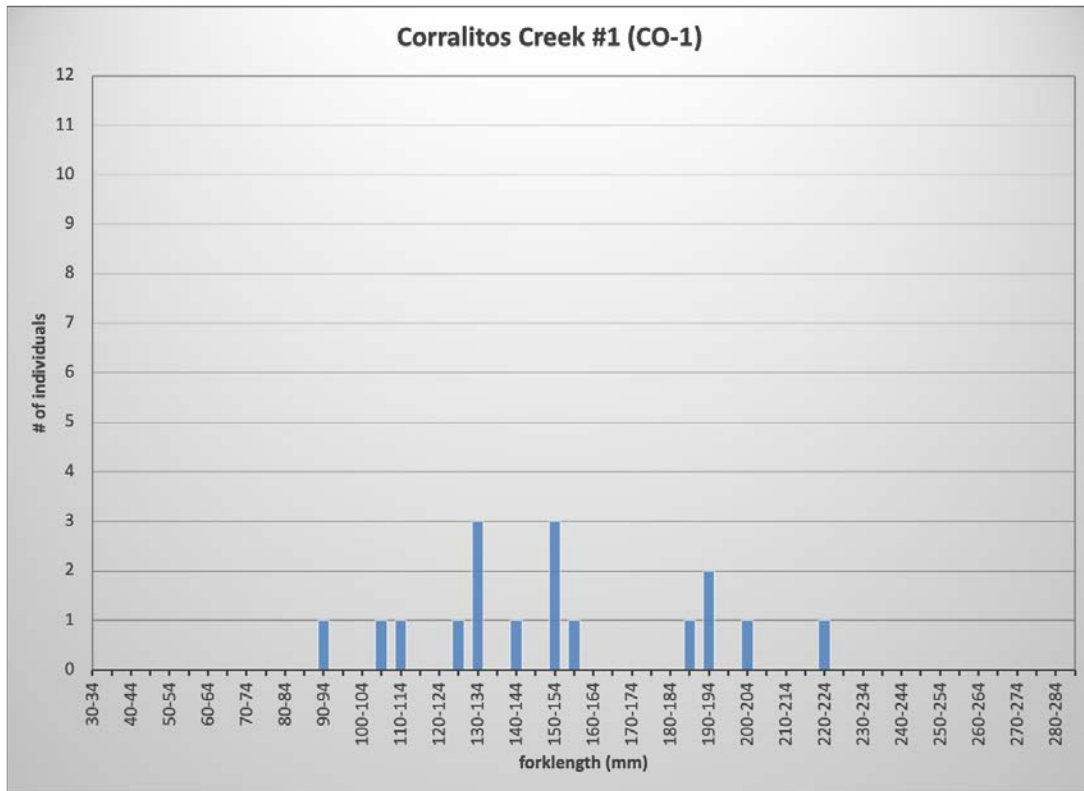
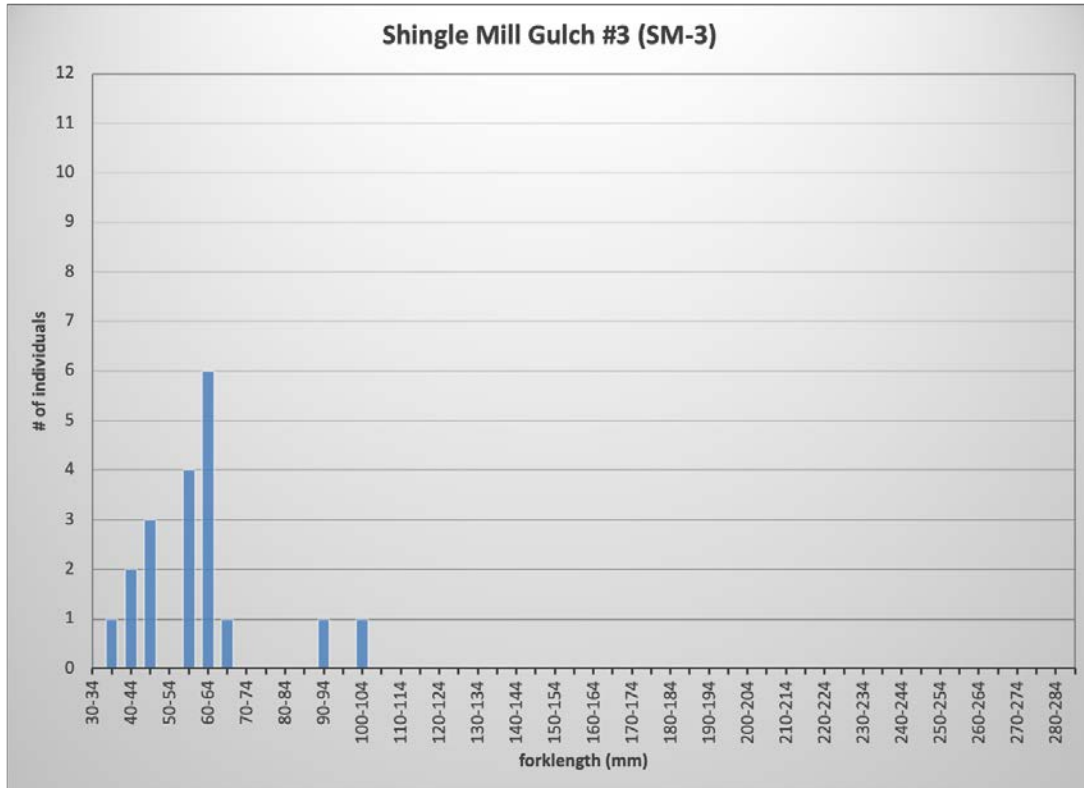
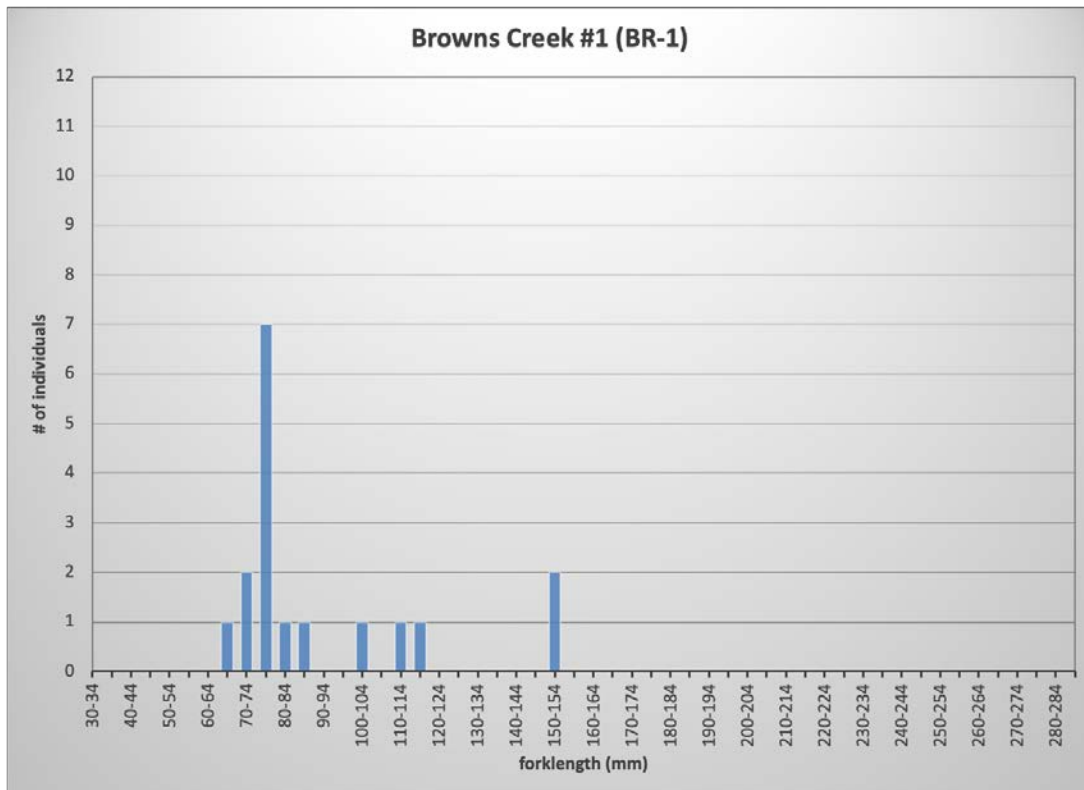
Figure 4. Forklength Distributions of Juvenile Steelhead at Eight Sampling Sites in the Corralitos Creek and Casserly Creek Watersheds, September/October 2023

of this effort. However, age class thresholds can also be determined fairly accurately from bimodal length-frequency distributions if a sufficiently large sample size is available. As this was not the case at some sites (e.g., Browns Creek #2), age class cutoffs were determined based on a combination of bimodal length-frequency distributions, professional experience conducting other long-term steelhead monitoring programs, and methods applied by other researchers in Santa Cruz County (e.g., Alley 2017; Sogard *et al.* 2009). For example, Alley (2017) generally classifies juvenile steelhead from non-mainstem San Lorenzo River sites as age 0 if SL is less than 75 mm. In a multi-year study of seasonal patterns of abundance, growth, and site fidelity of juvenile steelhead in the Soquel Creek watershed, Sogard *et al.* (2009) found that age 0 steelhead were generally less than 90 mm FL in October. Based on our observed length-frequency distributions and Sogard *et al.* (2009), we classified juvenile steelhead in the more open, low-gradient sites (i.e., Corralitos Creek #0 through #3) as age 0 if they were less than 90 mm FL, but in the more shaded upper watershed sites (i.e., Shingle Mill Gulch #3, and Brown Creek #1 and #2), 85 mm FL was generally used as the breakpoint between age 0 and age 1+ unless clear bimodal distributions suggested otherwise. This age classification scheme compares favorably to the bimodal distributions of standard-length frequencies and the Alley (2017) 75 mm SL breakpoint. In most cases, there was a clear demarcation between size modes of age 0 and age 1+ fish, but a small number of fish may have been incorrectly aged. Due to limited sample sizes, no attempt was made to segregate older fish into age 2 or age 3 categories and these fish were instead classified into the age 1+ category.

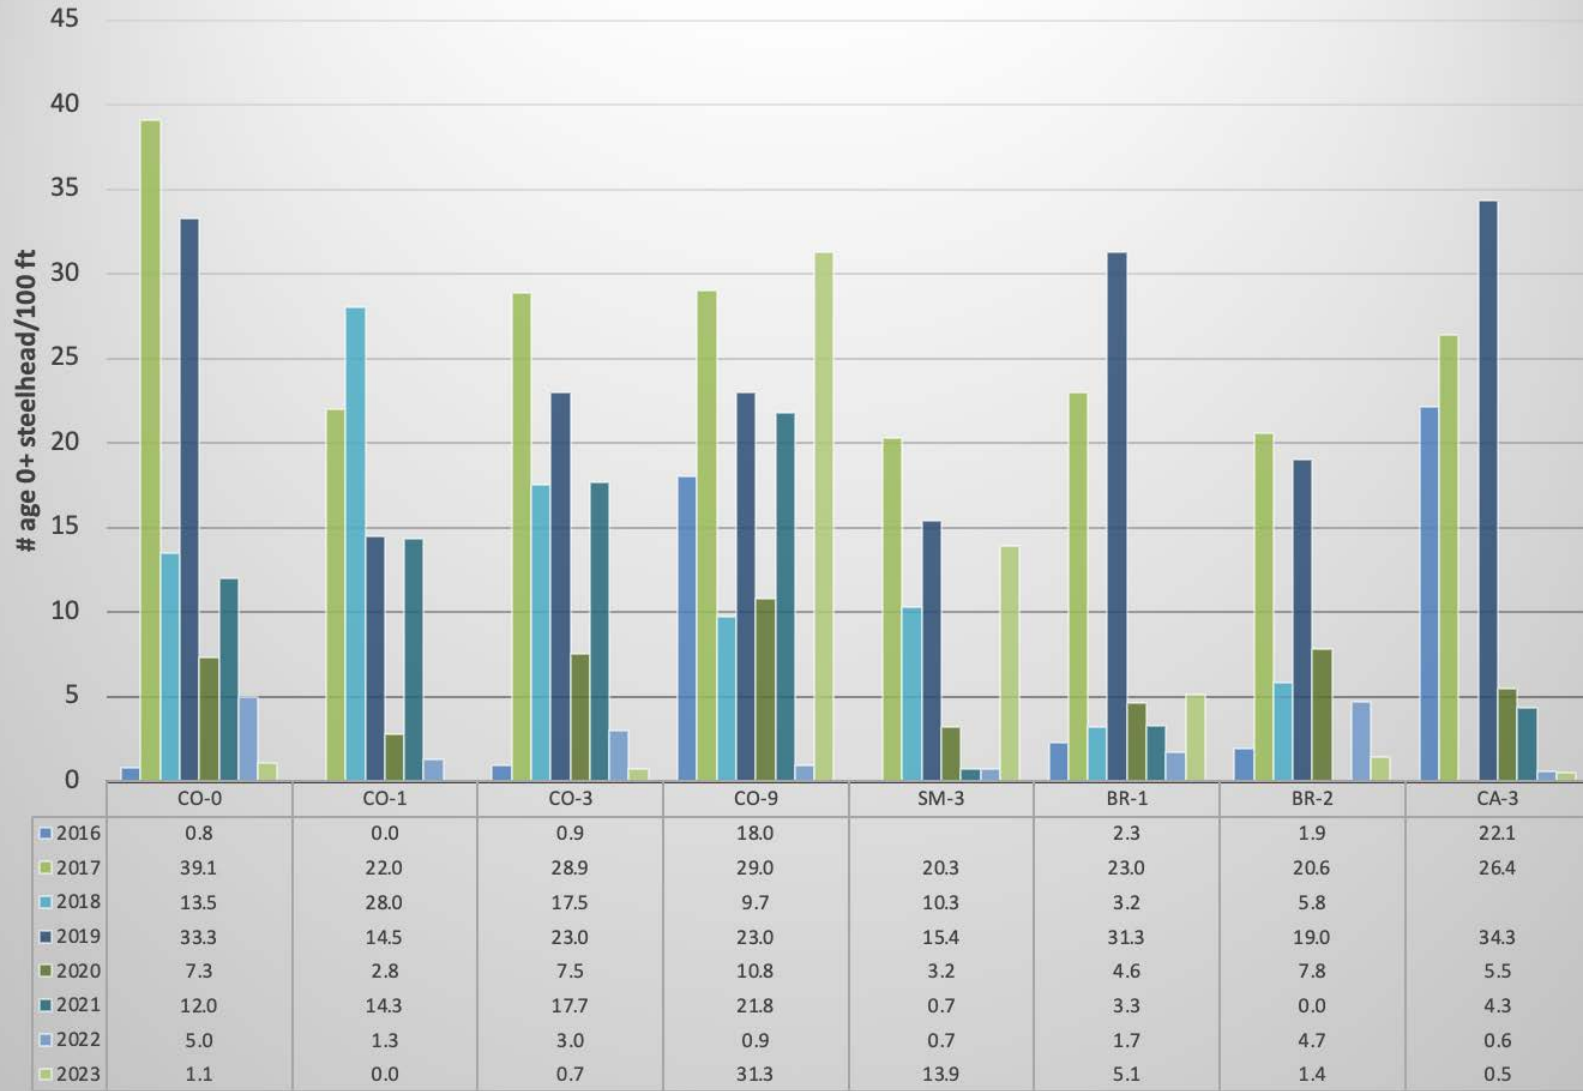
Age 0 Steelhead Densities, 2016-2023

Figure 6. Age 0 Steelhead Densities at Eight Sampling Sites in the Corralitos Creek and Casserly Creek Watersheds, 2016-2023 (data for 2016-2017 adapted from Alley [2017, 2018])

Water year 2020 was similar to 2018. After a few minor precipitation events in December, streamflows remained low throughout most of the peak adult steelhead migration period until another minor event occurred in late March, followed by a major discharge peak in early April at the tail-end of the migration season. The infrequent and untimely migration opportunities likely limited adult steelhead access, and therefore spawning success, in the Corralitos Creek and Casserly Creek watersheds in 2020. This lack of migration and spawning flows was the most likely cause of the marked decreases in age 0 juvenile steelhead densities observed at every sampling site in 2020 compared to 2019 (Figure 6) (Podlech 2020).

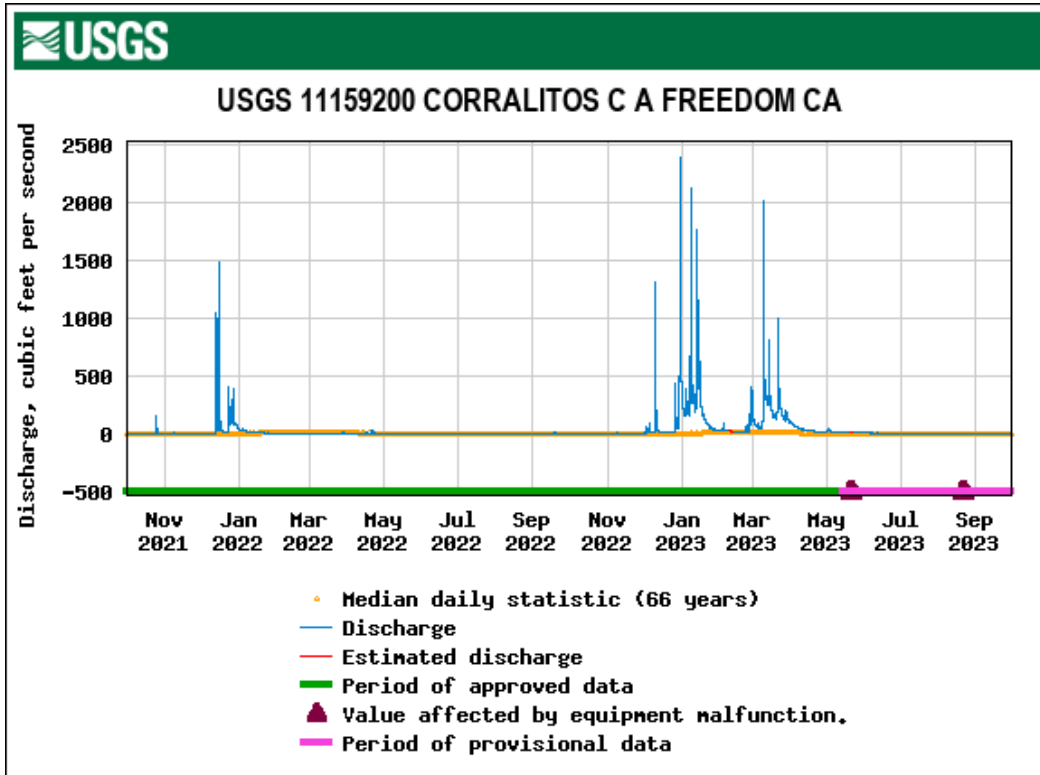
Figure 7. Mean Daily Discharge in Corralitos Creek at Freedom, USGS 11159200, Water Years 2022-2023

Water year 2022 was characterized by continued drought conditions. Although a few significant storm events occurred late December 2021 (Figure 7), the associated increases in streamflows occurred prior to the peak adult steelhead migration and spawning period. As in 2018 and 2020, essentially no additional precipitation occurred until late March 2022 at the tail-end of the spawning season. Age 0 steelhead densities that year were some of the lowest observed at the eight sampling sites since 2016 (Figure 6). Although age 1+ densities increased somewhat at most sites compared to the very low numbers observed in 2021, total juvenile steelhead densities in Shingle Mill Creek, upper Corralitos Creek (CO-9), lower Browns Creek (BR-1), and Casserly Creek (CA-3) were the lowest recorded in seven years of monitoring (Figure 5). In lower Corralitos Creek (CO-0, CO-1, CO-3) and upper Browns Creek (BR-2), total juvenile densities were the second lowest observed in seven years, with only the 2016 densities lower (Figure 5).

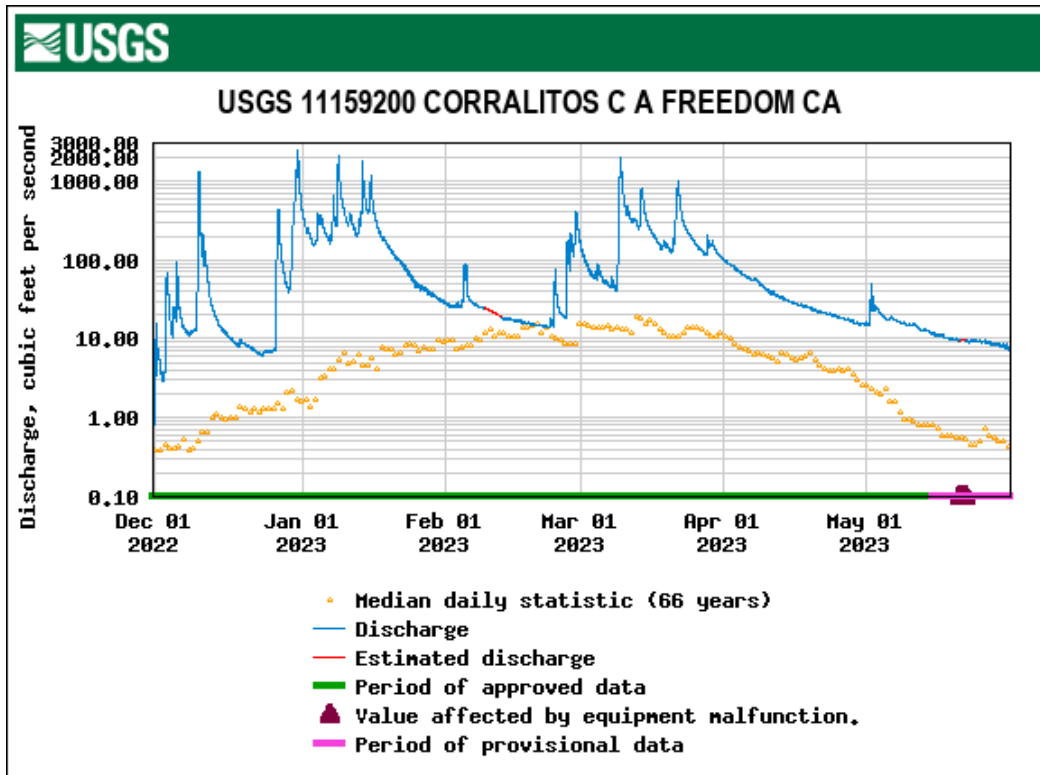
Figure 8. Mean Daily Discharge in Corralitos Creek at Freedom, USGS 11159200, December 2022-May 2023
