5.1.3 Repair Criteria

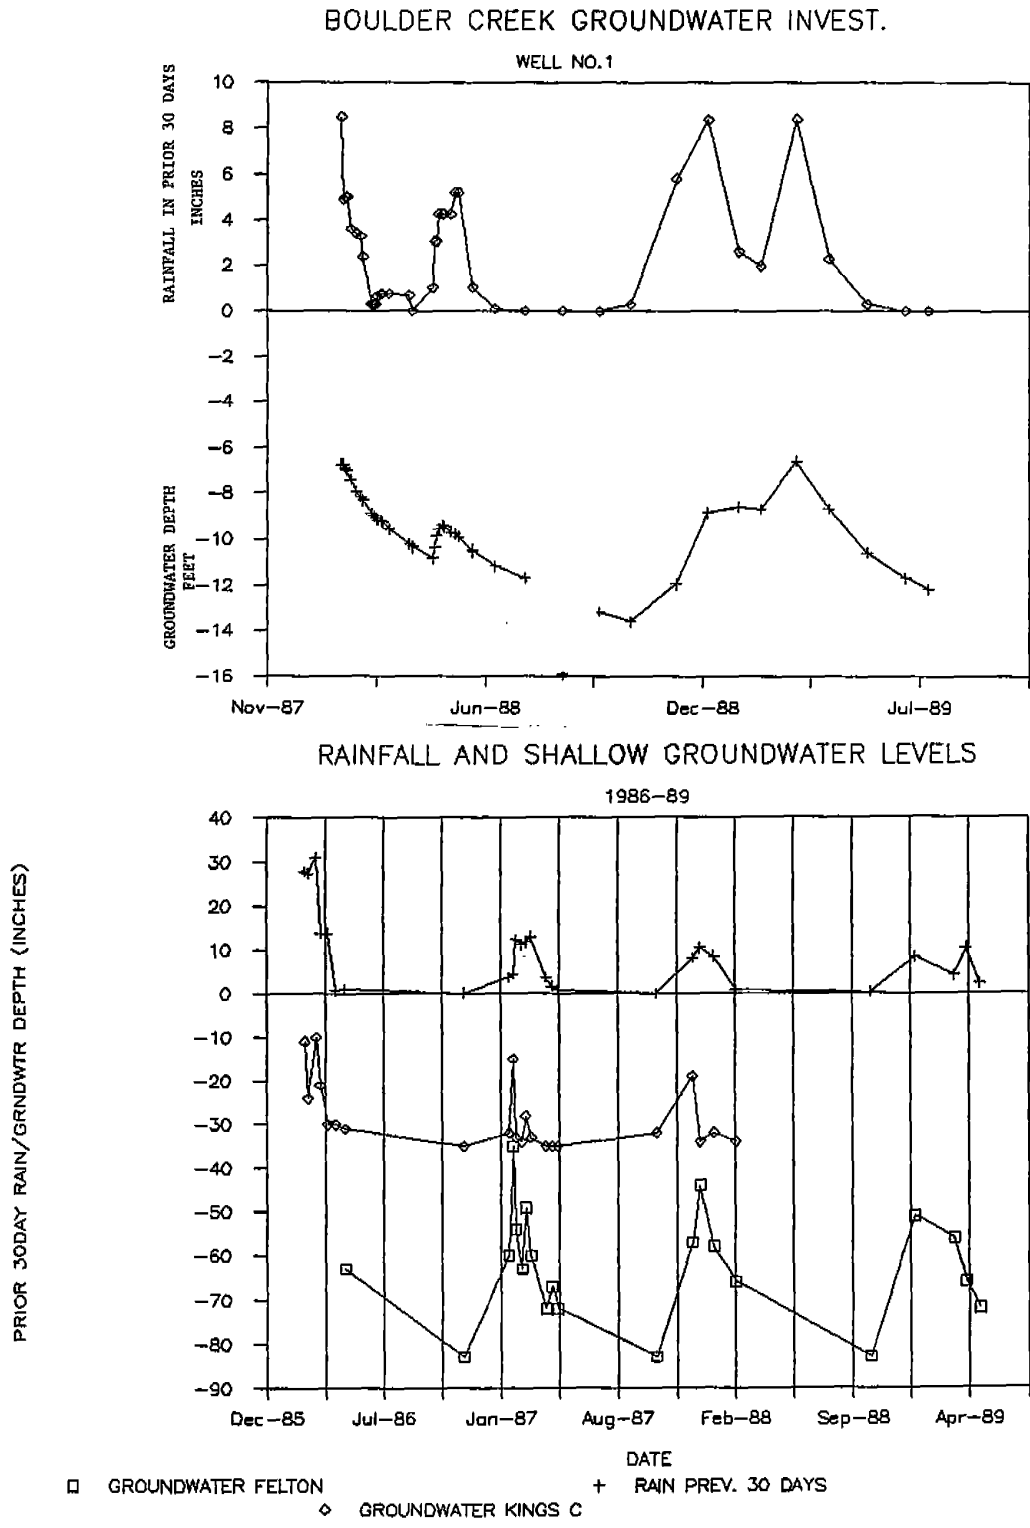
FIGURE 11: Rainfall and Shallow Groundwater Levels in Boulder Creek, Felton, and Kings Creek

Approximately 20 of the boreholes were cased with perforated pipe so that groundwater levels could continue to be monitored. This provided information on the response of groundwater to rainfall under different topographic and soil conditions. It has also enabled County staff to determine periods when groundwater is at typical winter levels. Despite the lower total levels of rainfall in the winters of 1987, 1988, and 1989, the borehole monitoring indicated that typical winter groundwater levels were reached for at least short periods of time each winter. However, the periods of high groundwater lasted only a few weeks during the drier winters. Information for several of the boreholes is shown in Figure 11. As of 1989, almost half of the monitoring wells had been lost to vandalism, infilling, or other damage. More wells will be placed in conjunction with future investigations.

The timing of the surveys, and the number of problems found are significantly affected by the amount of rainfall and soil saturation. Cumulative rainfall amounts are monitored, and groundwater levels in various parts of the Watershed are observed to determine when "normal" winter conditions have been reached. The County requires 60% of the average annual rainfall to have fallen, with at least 6 inches of rain in the previous 30 days, prior to allowing the determination of winter water table levels for the purpose of designing new systems. This is also used as a guideline for determining when to start the winter survey period. The survey period generally ends when water levels in groundwater monitoring wells are observed to drop significantly below normal winter levels. The proportion of observed failures also drops significantly as conditions dry out.

The duration of the period of high groundwater is of importance in determining the severity of the impact on septic system functioning. If groundwater is only high for a few days in immediate response to a storm, the impact is probably not significant. Rainfall is so heavy in the San Lorenzo Valley, that in most locations there are brief periods when soils are completely saturated. Under such conditions, septic systems may experience very transitory problems. But if the groundwater remains high for up to a month following heavy rains, it will present a significant constraint to system performance. Records of groundwater levels over time have been provided by HEA (1982), and the County's current monitoring network (see [Figure 11](#)). Of primary concern are the levels of groundwater that persist for periods of several weeks or more.

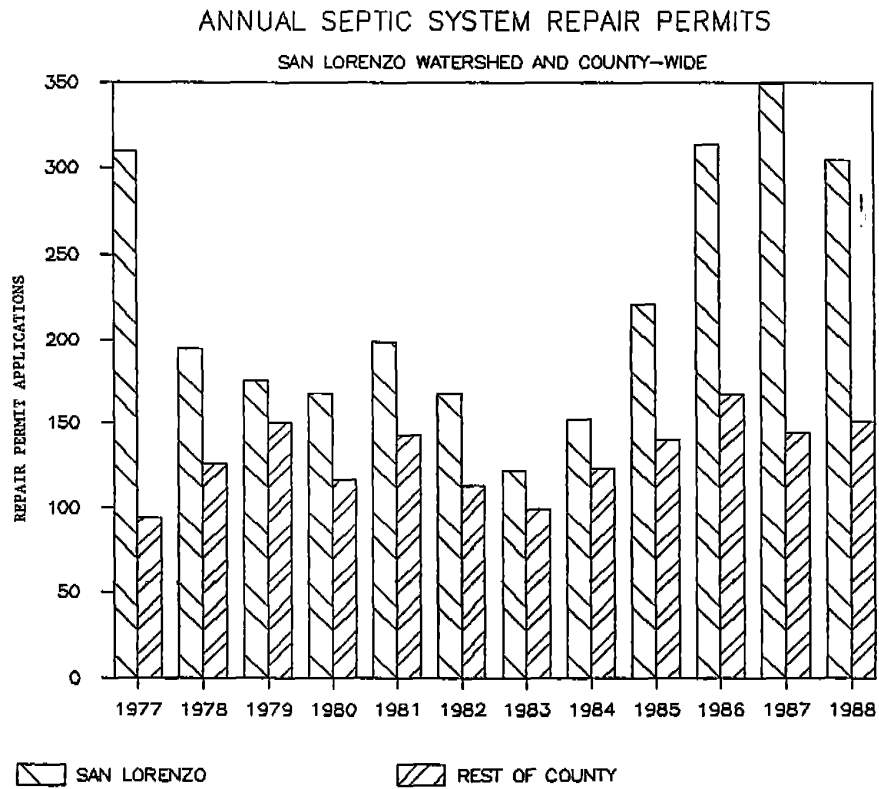
FIGURE 12: Septic System Repair Rates, 1977 - 1988

Long-term repair rates were assessed by looking at the annual number of repair permit applications received by the County each year. The repair permit activity over the last 10 years is shown in Figure 12. Current rates of repair permit activity are about 60% more than average rates prior to 1985, and are double the rates of that prevailed from 1982 to 1985. The repair rates for the San Lorenzo Watershed have also increased significantly in relation to repair rates for the rest of the County. At this time, although the Watershed contains about half of the systems in the county, repair rates

Whatever the reason, current rates of repair are much higher than the long-term rates, and should not be used as a measure of the number of systems with long-term problems. The possible presence of long-term problems may be better addressed by evaluating the effectiveness of current repairs, which is the subject of the next section.
